DOCUMENTS TO THE REQUESTOR  
EPA-R5-2015-000396

L0316485024 - Cook Co.  
Sun Machine Parts & Tooling  
ILD# 001994722  
SF/HRS

# **CERCLA Abbreviated Preliminary Assessment**

The Superfund Technical Assessment and Response Team (START) of Ecology & Environment, Inc. (E & E), was tasked by the Enforcement and Emergency Response Branch (EERB) of the United States Environmental Protection Agency (U.S. EPA) to conduct a site assessment at the Sun Machine Parts site in Chicago, Cook County, Illinois, under Technical Direction Document (TDD) S05-9701-003. START was tasked to prepare and implement a health and safety plan; compile and review background information; subcontract analytical services; document conditions at the site; conduct air monitoring and multi-media sampling; evaluate threats to human health and the environment; and make recommendations and provide options to U.S. EPA as to the potential need for a removal action, further investigation, referral to other government agencies or U.S. EPA programs, or other actions which may be prudent. The site assessment was performed in accordance with the National Contingency Plan (NCP) in the Code of Federal Regulations (CFR) Secti

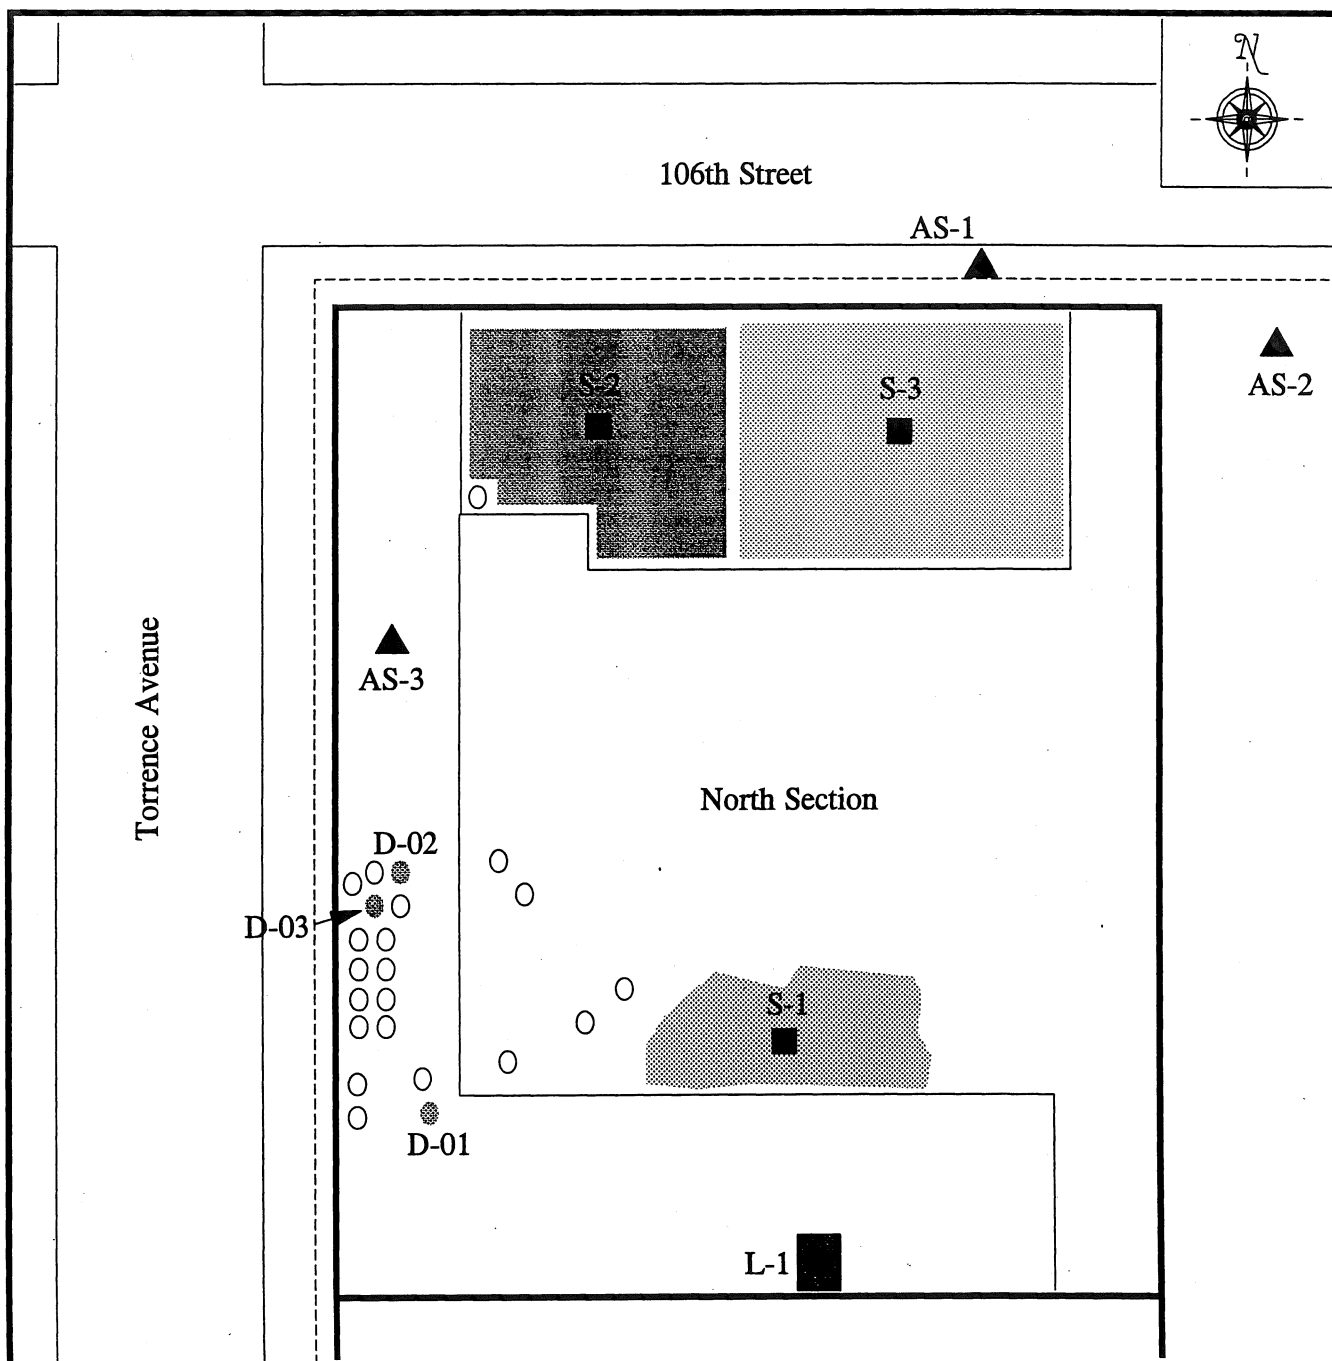
TITLE	Site Features Map	FIGURE #	3-1
SITE	Sun Machine Parts	SCALE	Not to scale
CITY	Chicago	STATE	Illinois
SOURCE	Ecology & Environment, Inc.	TDD #	S05-9701-003
		DATE	1997
		REVISED	NA

START and U.S. EPA performed a reconnaissance of the site in order to determine potential risks and appropriate sample locations. The most significant threats at the site were determined to be in the north section of the building. Site features, concentrating on this north section, are identified in Figure 3-1. Following the reconnaissance, START and OSC Bartman chose sample locations and analytical parameters. Two asbestos sample locations were identified outside of the building. The remaining locations were all in the north section of the building. Level C personal protective equipment was donned prior to collecting samples.

A significant amount of surface staining was observed in the north section of the building. Three composite soil samples were collected from this area. Composite sample S-1 was collected from an area of dark black staining with a significant amount of scattered miscellaneous debris. Composite samples S-2 and S-3 were collected, adjacent to each other, from areas of brilliant, colorful staining on an elevated pad in the north area of the north section of the building. All soil samples were analyzed for semivolatile organic compounds (SVOCs), Resource Conservation and Recovery Act (RCRA) metals, and cyanide.

A total of three drum samples were collected from 55-gallon drums in the north section of the building. Drum sampling was conducted in Level B personal protective equipment, with continuous air monitoring. Drum sample D-01 was collected from a 55-gallon drum of what appeared to be brown paint. No "flammable" labels were noted on the drum. The highest reading with a photoionization detector (PID) in the headspace of the drum was approximately 2,000 parts per million (ppm). Drum sample D-02 was collected from a 55-gallon drum which was labeled as a "flammable liquid". The PID reading in the headspace of the drum was approximately 500 ppm. The contents of the drum appeared to be green paint. Drum sample D-03 was collected from another 55-gallon drum which was labeled as a "flammable liquid". The PID reading in the headspace of the drum was approximately 500 ppm. Its contents appeared to be gray paint. All drum samples were analyzed for pH, flash point, volatile organic compounds (VOCs), SVOCs, and RCRA metals.
